PROCEEDINGS OF THE 16th
MULTIDISCIPLINARY CONFERENCE ON
**SINKHOLES AND THE ENGINEERING AND
ENVIRONMENTAL IMPACTS OF KARST**

CROSSHOLE MAPPING OF A SUBSURFACE VOID

Peter J. Hutchinson

Kentucky River Lock and Dam 8, Jessamine and Garrard Counties, Kentucky, were constructed in 1900 and have for the past 120 years experienced significant degradation due to karst geology. The cement capped wood-cribbed dam is anchored to the karstic Grier Limestone. Due to the dissolution of limestone, water seepage around and under the dam has created unstable conditions for the dam that required engineering rehabilitation many times over the years. A recent rehabilitation project to prevent river water from seeping under the dam included installing engineered secant grout curtains anchored into the Grier Limestone.

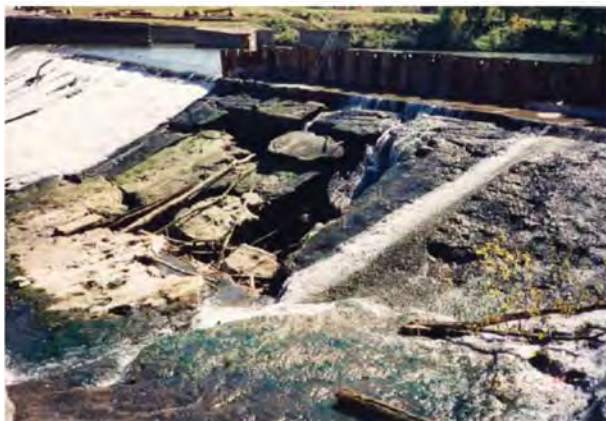
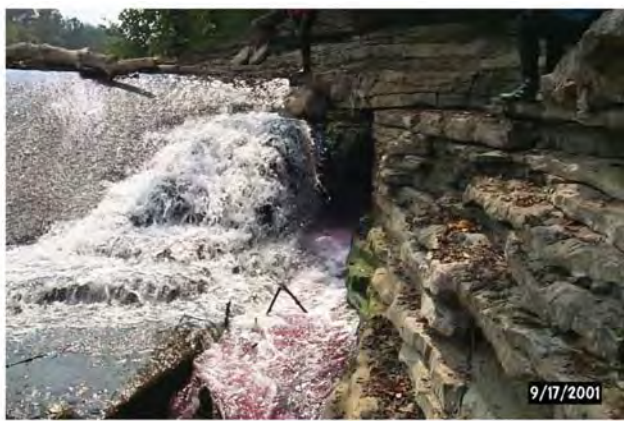
Kentucky River Lock and Dam 8 are located between Garrard and Jessamine Counties, Kentucky (Figure 1). Dam 8 has experienced deformation, erosion and collapse since its completion in 1900 primarily due to karst conditions (Welshans et al., 2011). The 120-year-old crib-work dam was repaired several times over the years and was, as of 2011, a concrete-capped, rock-filled timber crib dam (Figures 2 and 3). The original lock and dam were constructed between 1898 and 1900 as a timber crib structure, consisting of an outside frame of timbers filled with dirt and rock. A cement cap was installed in the 1920s. Construction from 1993–1995 included removing a river guide wall, filling downstream face voids with concrete, and placing derrick stone below the dam. In 2001 a concrete cutoff wall was built in the lock chamber and lock filling valves were sealed. Grout bags

Figure 3. Left photo shows the collapsed portion of the dam near the left abutment in 1994. Right photo shows dye leakage at the left abutment in 2001 (Welshans et al., 2011).

were placed along the far abutment in 2002 to cut off leakage. The replacement dam will be a concrete-filled cellular sheet pile structure upstream of the existing dam (USACE, 1999).

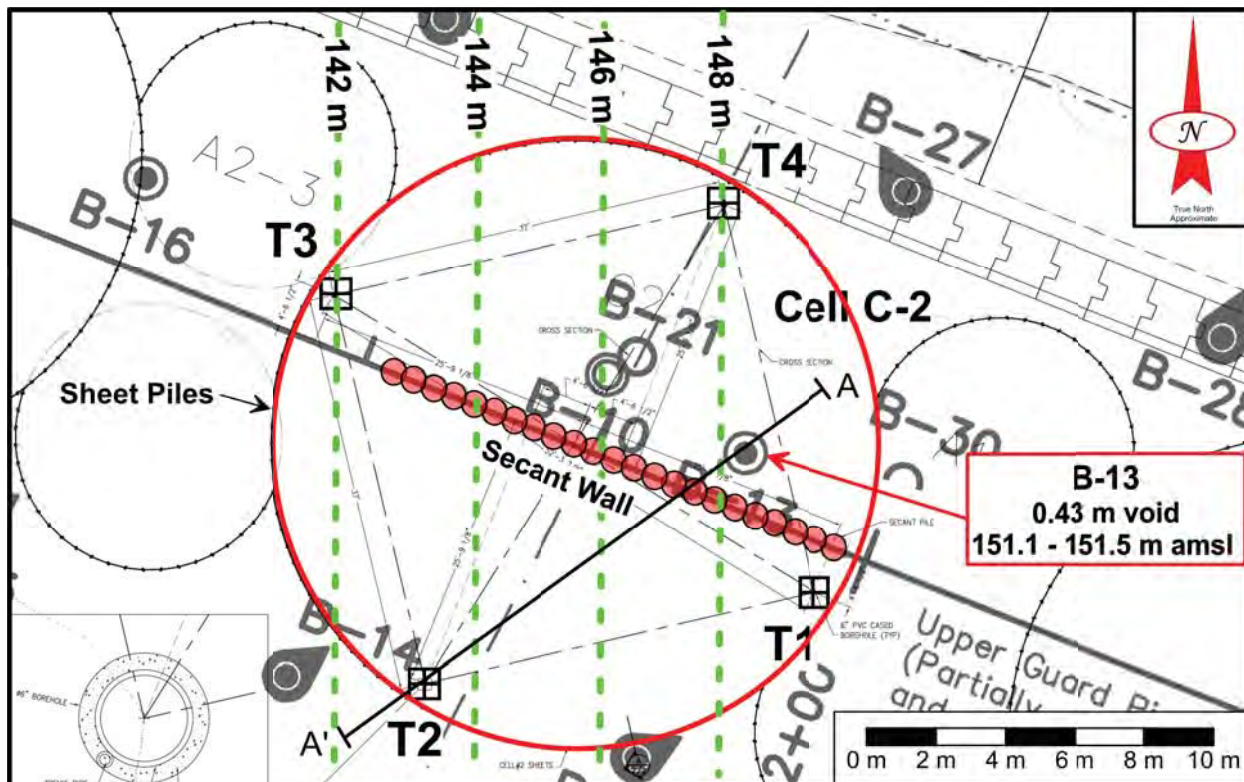
Boring B-13, within coffer dam Cell C-2, penetrated a 0.43 m void (Figures 3 and 6). The concern was that

Figure 4. Location of 4 crosshole borings (T-1, T-2, T-3, and T-4) and boring B-13 within coffer dam Cell C-2 from design drawing for the rehabilitation of the dam (Welshans et al., 2011). Depth contours (in m amsl) of a fracture zone are shown as green dashed lines.

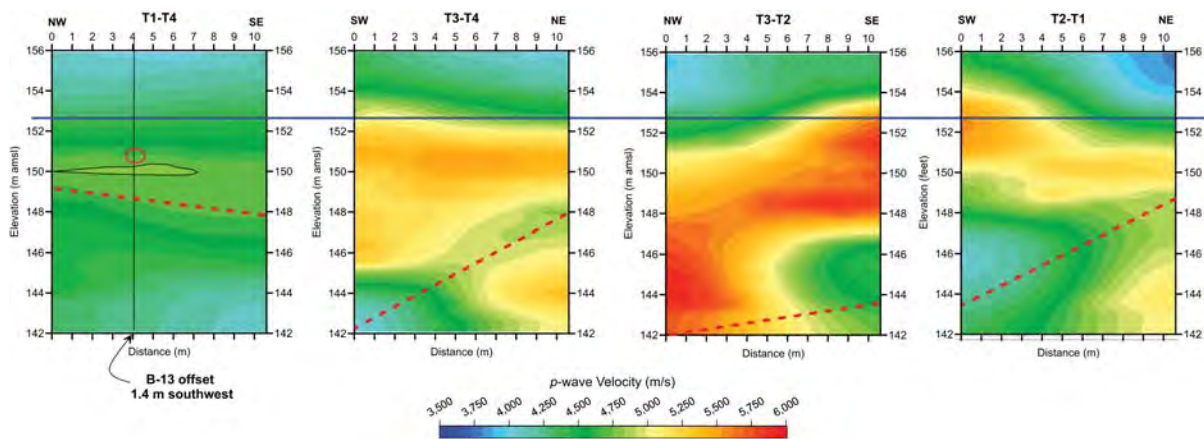
collected, the *p*-wave velocities range from 3,500 m/s to 6,000 m/s, consistent with the velocity of limestone. Velocities greater than 5,000 m/s (yellows and reds) are interpreted to be competent bedrock. Lower velocities, values less than 5,000 m/s (blues and greens), are considered weathered/fractured zones (Figures 10 and 11). The lower velocities above the top of the limestone (152.4 m amsl) reflect the poorly consolidated conglomerate and engineered materials used to stabilize the floor of the coffer dam. Data appear to be consistent in profiles sharing the same boreholes as the tightness of the velocity contours correlate well within a few hundred m/s.

Profile T1–T4 exhibits lower *p*-wave velocities throughout and is interpreted as heavily fractured and weathered. Boring B-13 is offset approximately 1.4 m to the southwest at position 4 m along the profile (Figure 10). The anomaly encountered during the drilling of B-13 is present within this tomograph, indicating that the void is at least 1.4 m wide and 7 m long. A low velocity zone at the base of the tomograph probably represents vuggy conditions associated with the fracture noted on tomograph T3–T4.

Profile T3–T4 shows lower *p*-wave velocities above the top of the limestone at 152.4 m amsl associated with the coarse gravel and engineered fill (Figure 10). A frac-

fractured/weathered zone is depicted in the tomograph from between elevations 142 to 148 m amsl.

Profile T3–T2 also exhibits lower p -wave velocities above the top of the limestone (Figure 10). This site also shows a potentially fractured/weathered zone that is better displayed on tomograph T2–T1. Competent rock is inferred as the green to red color contours surrounding this low velocity zone.

Profile T2–T1 also exhibits lower p -wave velocities above the top of the limestone (Figure 10). A potentially

fractured/weathered zone exists between position 0 m to approximately position 2 m and occurs between elevations 144.3 to 146.3 m amsl. Competent rock is inferred to be represented by the green to red color contours surrounding this low velocity zone.

Figure 10. Crosshole p -wave velocity tomographs between each cased boring showing top of limestone (blue line); possible void (thin black line on T1–T4) below projected B-13 void (red circle); and fracture (red dashed line).

Seismic methods rely on acoustically quiet areas and are negatively impacted by surrounding noise. The flowing river and water rushing into the cell did not provide a quiet environment for the survey and may have interfered by camouflaging the first arrival times of the *p*-wave. It is recommended to ground truth the seismic data, particularly in the interpreted weathered/fractured zones.

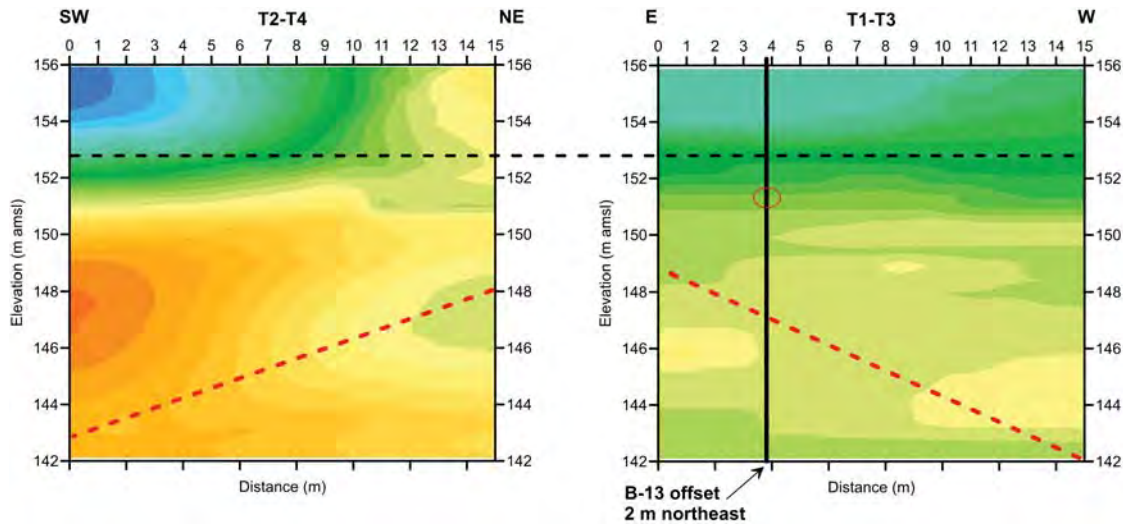
Profile T2–T4 crosses the site for a distance of 15 m, which is a long distance for a seismic event to travel without the seismograph recording noise (Figure 11). A small, potentially fractured/weathered zone is present between positions 12 m and 15 m and at an elevation of between 146 m and 148.5 m amsl. This zone may represent vuggy conditions.

Profile T1–T3 exhibits lower p -wave velocities throughout and is interpreted as heavily fractured and weathered. This profile is oriented parallel to the strike of the fracture and does not show up well (Figure 11). Boring B-13 is offset from the profile approximately 2 m to the northeast at 4 m along the profile.

Figure 11. Crosshole p-wave velocity tomographs between each cased boring showing top of limestone (black dashed line); projected B-13 void (red circle); and fracture (red dashed line). Velocity color scale is shown on Figure 10.

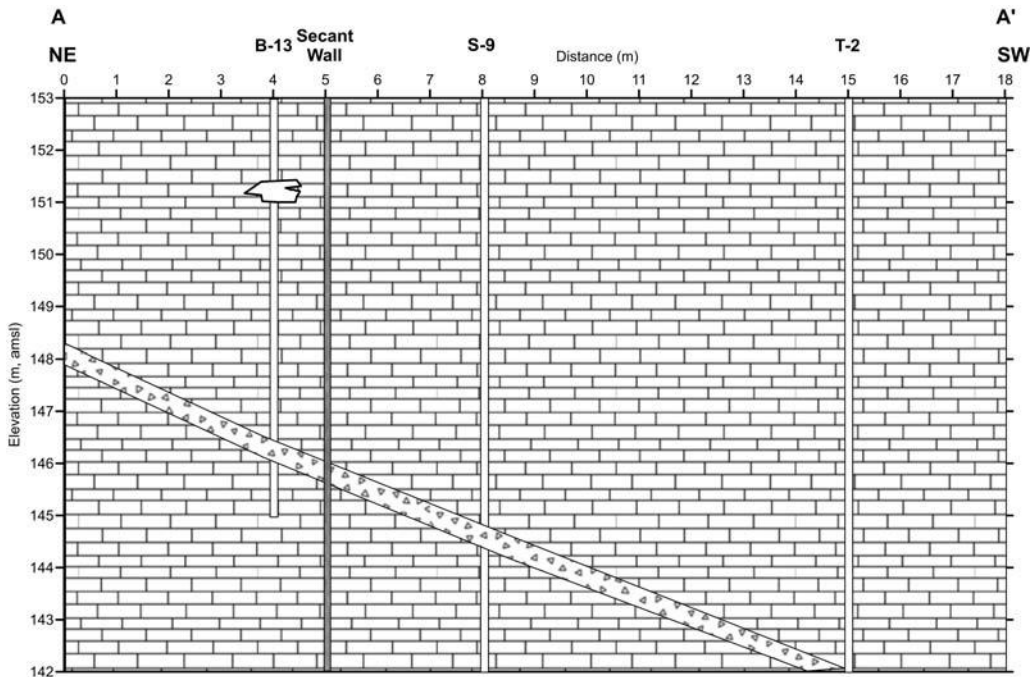
The fracture zone strikes N1°E and dips 30°W (Figure 12). Hatton (2018) reported strikes of fractures in

surface measurements with orientations of between N4°W to N11°E, consistent with the results presented here. The fracture zone is inferred to be 1 meter wide and may not be present below 142 m amsl.

Figure 12. Cross section A-A' showing the relationship of the secant wall to the fracture zone (see Figure 4).

Cell C-2, a steel-pile coffer dam, was filed with a cement-grout mix prior to the installation of the secant wall. After curing, a series of overlapping grout-filled borings that represent the secant wall were installed ver-

tically into the cement-filled coffer dam. Additionally, several grout-filled borings were installed 1 m on either side of the secant wall alignment at an angle of 15° (from the vertical) to the right or left of the wall. The purpose of the secant wall is to decrease the flow of groundwater through the formation as water flows downstream. The flow of water through the formation could destabilize the dam. Clearly the secant wall, as installed, will decrease the potential for groundwater to seep through the dam.
