Case Studies of Mine Voids Using Continuous Vertical Electrical Sounding Methods

*Proceedings of the 2nd International Conference on Environmental and Engineering Geophysics; In,
Geophysical Solutions for Environment and Engineering; Eds., Y. Xu, J. Xia, C. Chen
4-9 June 2006, Wuhan, China, Pp. 270 - 280*

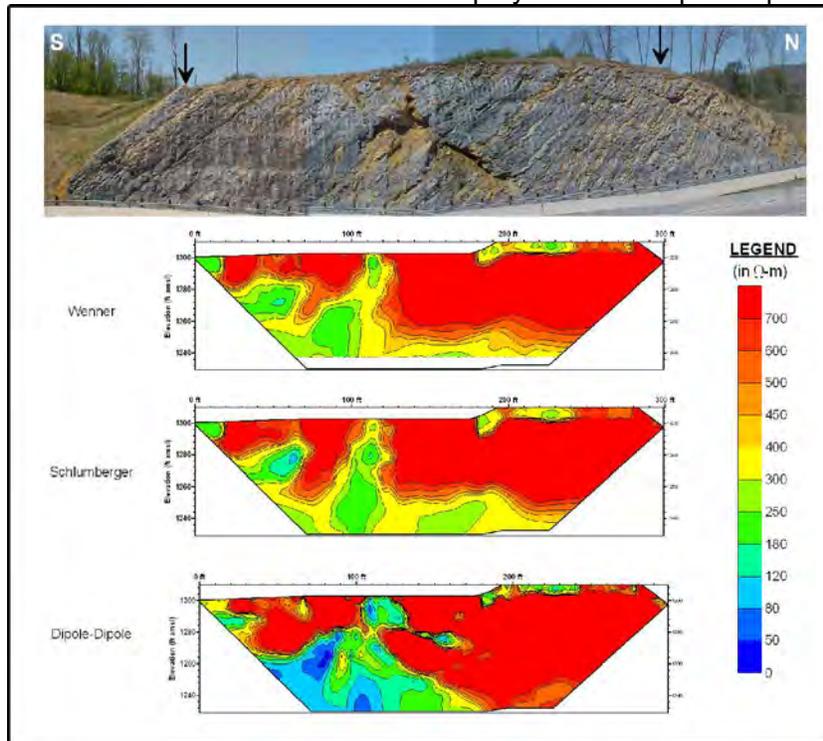
Figure 2. Selected CVES-array images of the recently exposed outcrop in State College, Pennsylvania.

The construction of a highway ramp exposed the formation and a fracture-derived void. Close inspection of the partially clay-filled fracture void shows that the void opens up into the outcrop. The top of the outcrop was stripped of 2.1 meters of soil cover on the south side and the north side was left intact (Figure 2).

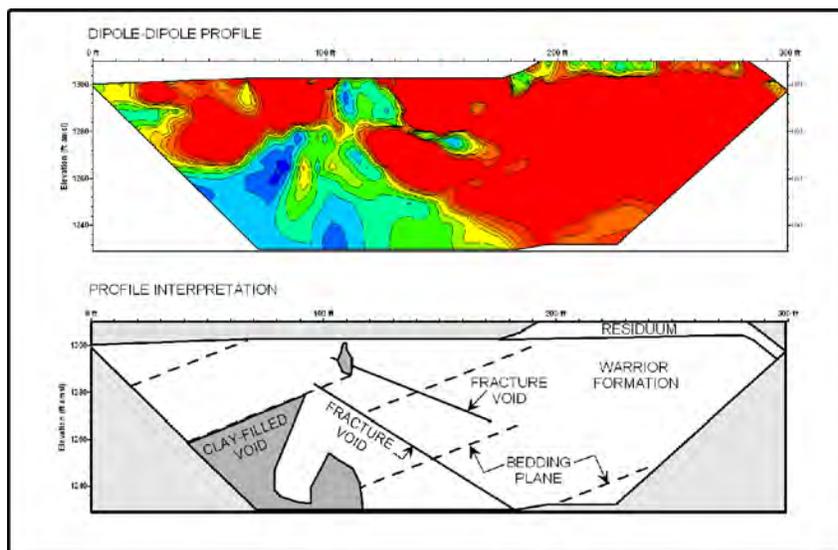
Massive limestone with a measured apparent resistivity of greater than 300 Ohm-meters is ubiquitous throughout the outcrop (Figure 3). The southern base of the outcrop has much lower apparent resistivities, suggesting that there is a void or at the least fractured and/or weathered bedrock within the outcrop. The northern half of the profile area had in-situ residuum at the surface; whereas in the southern half of the survey, the residuum had been stripped off during highway construction.

The profile imaged the centrally-located fracture-void, which has a 32° dip to the north. Further, the profile imaged bedding to a limited degree. The profile also predicts that another fracture may exist in the subsurface to the north of the one exposed at the outcrop. The weathered/fractured zone to the south is also well displayed on the dipole-dipole profile.

Figure 3. Interpretation of the dipole-dipole CVES profile.

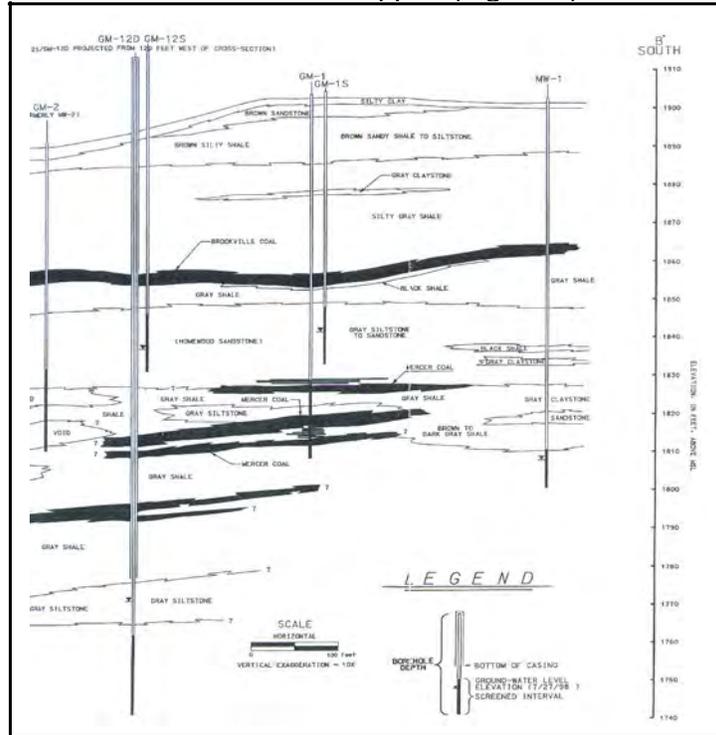
Figure 5. Generalized north-south cross section showing the coal seams and underclays in the St. Marys, PA area (scale as shown; from HydroSystems Management, Inc., 1998)

Bedrock is part of the lower section of the undifferentiated Pennsylvanian-aged Pottsville Group (Figure 5). The Pottsville Group is relatively flat-lying and described as a weathered, brown claystone to siltstone with local thin coal seams. The Brookville Coal is exposed at the surface in the area and is underlain by the upper Mercer coal complex. The Upper Mercer Coal Complex occurs approximately 35 feet below the Brookville.

The Brookville Coal consists of approximately 18 inches of a low grade bituminous coal and a 2- to 3-foot thick plastic underclay (Figure 5). The underclay was exploited by surface mining methods at the turn of the last century for reportedly making sewer pipes. The Brookville Coal, a by-product of the clay mining operation, was used for firing the ovens. The underclay to the Brookville Coal is a plastic clay, reportedly rich in kaolinite.

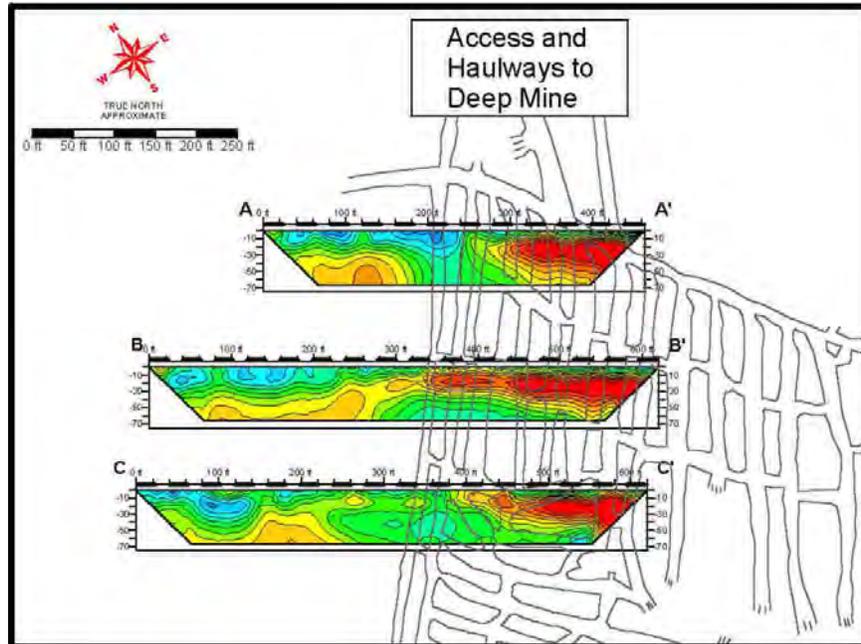
Inversions of measured apparent resistivity values with depth are interpreted to be subsurface anomalies (i.e., voids). In a relatively flat-lying homogeneous clastic stratigraphic setting, the resistivity profiles should show horizontal bedding; however, non-horizontal phenomena are interpreted to be subsurface voids. Deep apparent resistivities of less than 90 Ohm-meters (i.e., below the higher resistivities) were considered to be anomalous (Figure 6).

was procured from the Pennsylvania Department of Natural Resources and overlain on the profiles in as accurate a position, as is possible using the hand-drawn 80 year-old document. The profiles show an excellent agreement with the mine as mapped (Figure 6).

Figure 6. Hand-drawn mine map superimposed upon the exact locations of the EI profiles (scale as noted).

Profile A-A' (Figure 6) shows that there is no development of the mine to the northwest, which is consistent with the mine map. The southeastern portion of the profile indicates the presence of an inversion that extends 100 feet to the southeast. The map shows the presence of the main haulway and adjacent room located in this area. At approximately 350 feet along the profile, a minor inversion is noted and coincides with a room.

Profile B-B' (Figure 6) also shows no development of the mine to the northwest, consistent with the mine map. An inversion is present from 350 feet to 525 feet along the profile. The mine map shows that this inversion is the main haulway and a series of rooms that extend to the end of the profile. Note the room shown at the end of the profile coincides with a room.

Profile C-C' (Figure 6) indicates that the mine is developed to the northwest. The mine map also depicts a room extending to the northwest at this location. To the southeast, the profile shows a series of rooms that are evident on the mine map. One pillar is only vaguely shown on the profile. Collapse of the pillar may have interfered with the imaging of this feature.

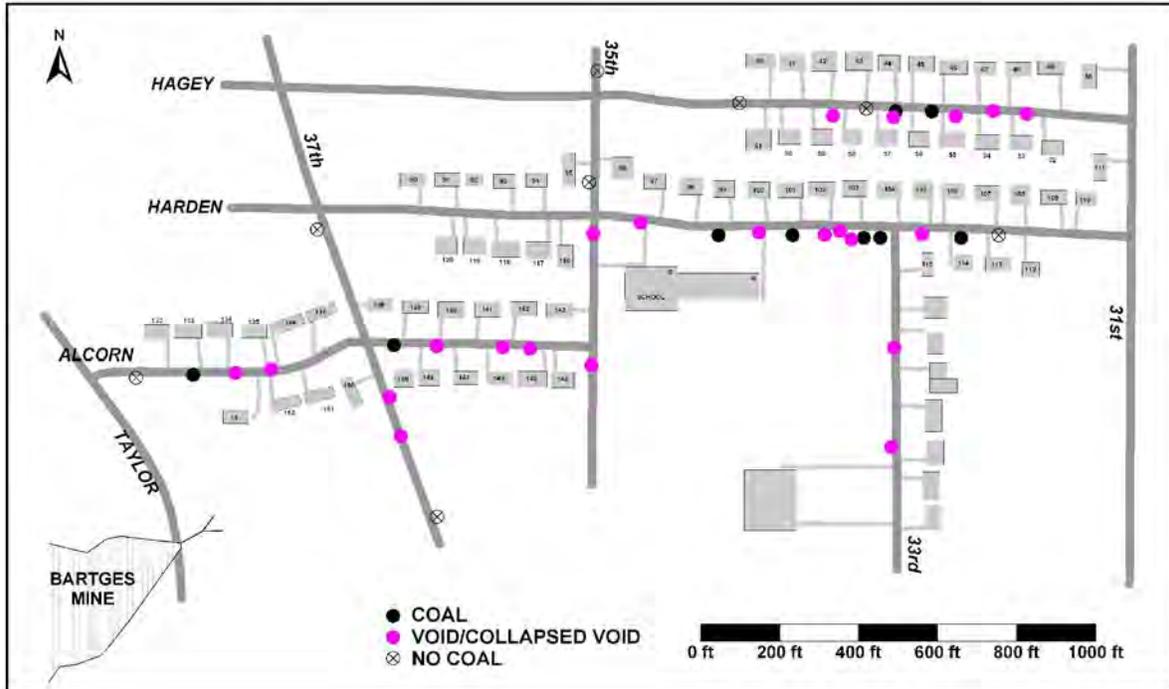
The initial drilling program indicated that the occurrence of coal was local and not easily determined; consequently, voids would be difficult to locate and remediate (Figure 8). Twenty-five borings of 47 advanced, encountered mined-out areas (void, collapsed void, fractured overburden); 12 borings recovered coal, and 10 encountered non-coal deposits (Collins, 2001). An earlier investigation concluded that 1 church, 1 school, and potentially 56 homes lie above the mined out area.

Figure 8. Location of borings in the Barbarton subdivision showing the occurrence of voids, coal, and non-coal deposits (scale as noted).

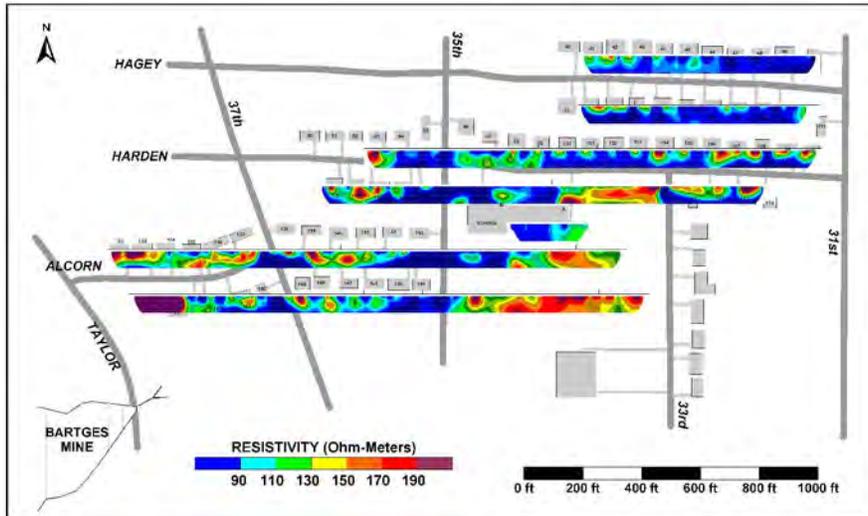
In a relatively flatlying homogeneous clastic stratigraphic setting, the resistivity profiles should show horizontal bedding; however, non-horizontal phenomena are interpreted to be subsurface voids. Resistivities of less than 90 Ohm-meters were considered background and resistivities between 90 Ohm-meters and 200 Ohm-meters were considered to be anomalous (Figure 9).

The area investigated shows obvious signs of subsidence and many residents complained of the appearance of holes in their yards. The resistivity profiles show that several voids exist in the shallow subsurface at the site (Figure 9).

Figure 9. Seven electrical imaging lines located along the profile spatial position; showing undisturbed rock in dark blue and voids in red (no vertical exaggeration).

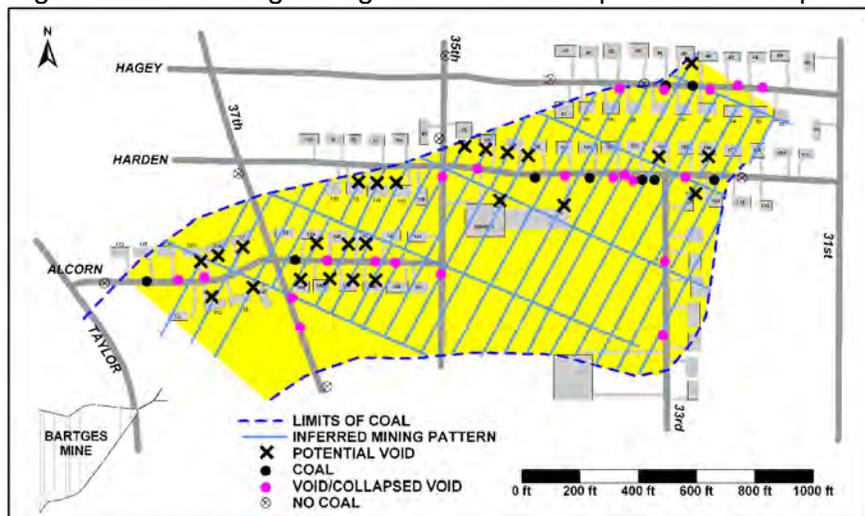
Additional analysis of the study area mine can be derived from a review of the 1876 Bartges Mine map, which delineated a mining pattern to the development of the Bartges Mine (DeLong, 1981). Presumably mining in the study area occurred in a pattern similar to that of the Bartges Mine. This assumption is not too difficult to accept since miners often exploit coal preferential to butt and face cleat orientations, which would be structurally similar for both mine areas (Figure 10). Further, the presence of coal or voids in borings and the location of geophysically-imaged voids show a good agreement with the predicted mine pattern (Figure 10).

Figure 10. Projection of the Bartges Mine development orientation onto the study area, showing the boring and imaging analysis (scale as noted).

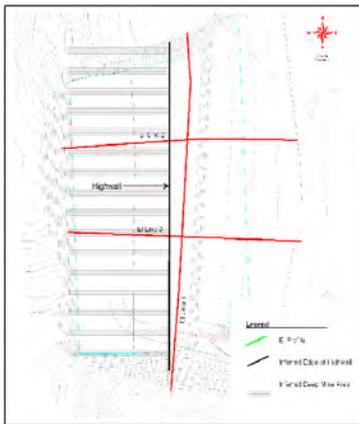
Three CVES profiles were collected to determine the position of the highwall and to determine if the property behind the highwall was deep-mined (Figure 12). Line 1 (Figure 13)

Figure 12. Location map of CVES profiles and highwall location interpretation (contour interval 2 feet; scale 1" = 100').

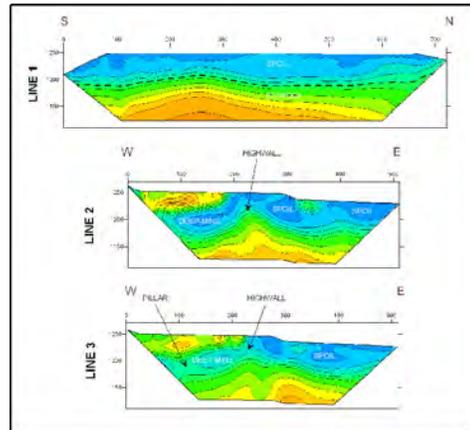
Figure 13. CVES profiles from the Case Study 3 area (no vertical exaggeration, scale as shown in feet).

imaged the base of the spoil (dashed line), which is approximately 50 feet below grade. The base of the relatively flat-lying 8-foot thick Pittsburgh coal has been mapped at an elevation of approximately 1,180 feet above mean sea level, which is consistent with the results of the CVES survey (Skema, 1987). Lines 2 and 3 (Figure 13) were collected normal to the buried highwall and show the edge of the highwall in profile. Further, the inversion in apparent resistivities west of the inferred location of the highwall is interpreted to be a deep-mine void. (Figure 13).

Elevated resistivities within the inferred deep-mined portion of Line 3 are interpreted to be in-situ coal pillars (Figure 13). If this is the case, then CVES can be used, in the shallow subsurface, for potentially mapping coal mine pillars, thus providing better control for the use of the property.
