PROCEEDINGS OF THE 16th
MULTIDISCIPLINARY CONFERENCE ON
**SINKHOLES AND THE ENGINEERING AND
ENVIRONMENTAL IMPACTS OF KARST**

CROSSHOLE MAPPING OF A SUBSURFACE VOID

Peter J. Hutchinson

Kentucky River Lock and Dam 8, Jessamine and Garrard Counties, Kentucky, were constructed in 1900 and have for the past 120 years experienced significant degradation due to karst geology. The cement capped wood-cribbed dam is anchored to the karstic Grier Limestone. Due to the dissolution of limestone, water seepage around and under the dam has created unstable conditions for the dam that required engineering rehabilitation many times over the years. A recent rehabilitation project to prevent river water from seeping under the dam included installing engineered secant grout curtains anchored into the Grier Limestone.

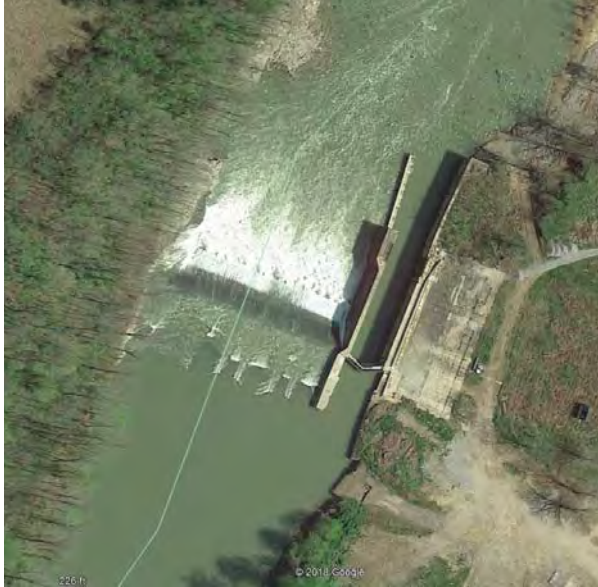
Figure 2. Aerial view to the northeast (upstream) of Dam 8 on the Kentucky River as of 2017 showing the completed concrete-filled cellular sheet pile structure.

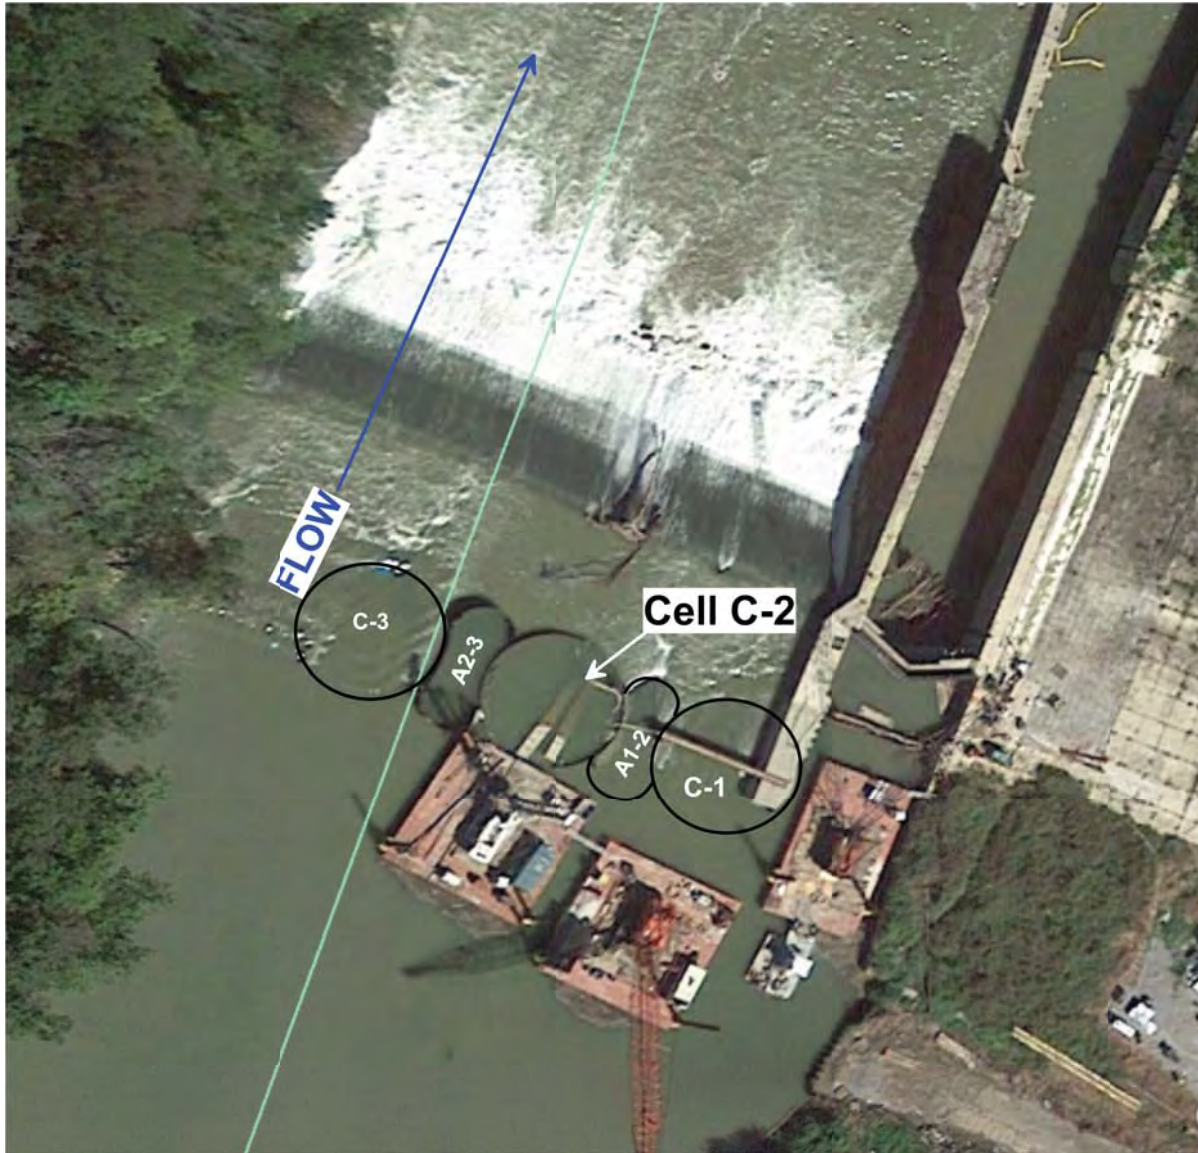
Figure 5. Location of coffer dam, Cell C-2, within the cellular dam system (September 19, 2016). The 18-m diameter coffer dam is in the process of being tremie grouted with a cement-grout mixture subsequent to the crosshole work (September 2015).

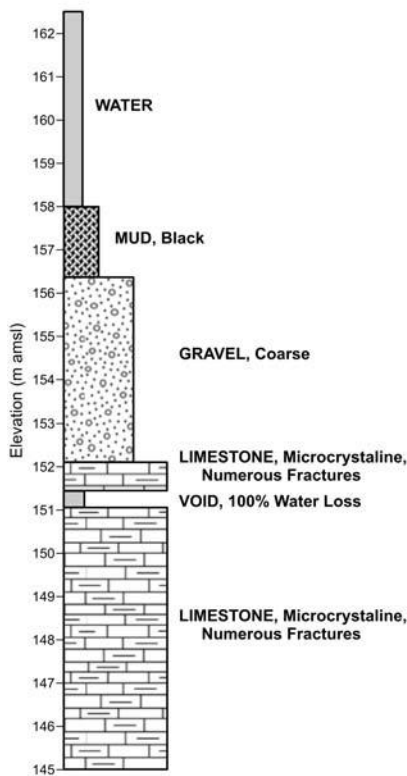
Boring B-13, within coffer dam Cell C-2, penetrated a 0.43 m void (Figures 3 and 6). The concern was that

Figure 6. Stratigraphic column from boring B-13.
